LIFERAFT ON THE BOW PROJECT

PROJECT DEFINITION

Period of Trial: 2 years – commencing March 2001

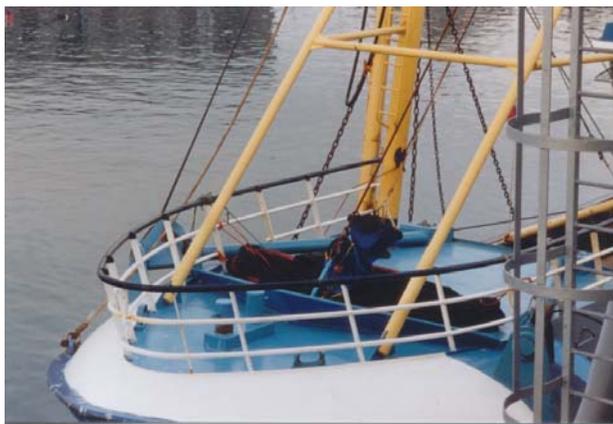
Fig. 1

The photograph (fig.1) below shows the whole foredeck area. The Skipper and Mate originally suggested the liferaft container should be placed aft of the breakwater, however it was determined that such a position would not be advantageous in a float free situation and it would be better placed forward of the mooring bitts where the only obstruction to floating free was the rail itself.

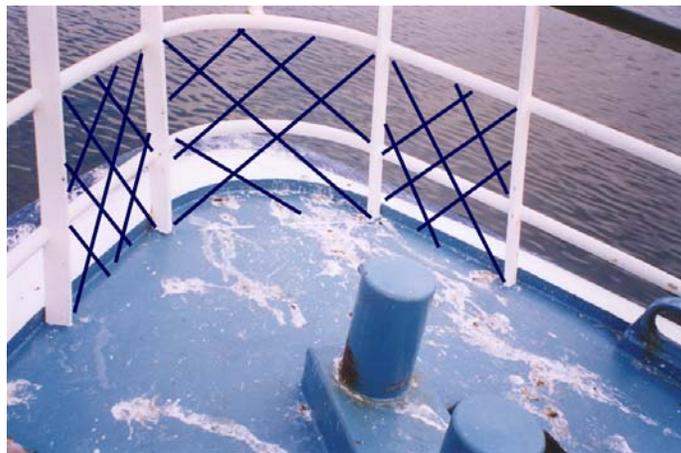
Fig. 2

In the event, the owners opted to fit a series of angled steel bars to the rails in the area indicated in the illustration below.

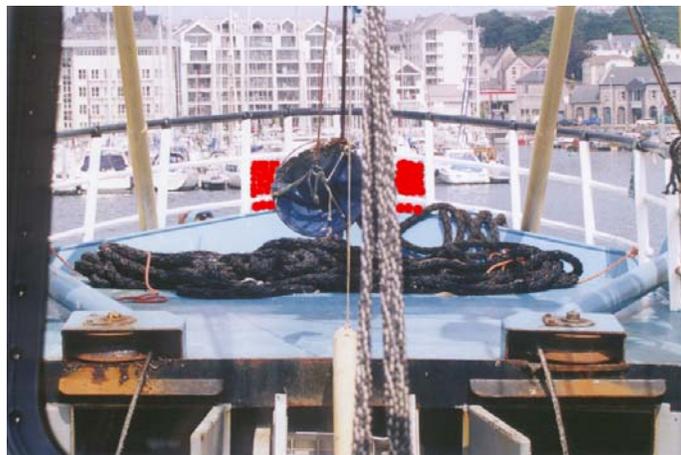
It may be seen in Fig. 3 below, that placing a liferaft container in the position suggested would not have an adverse effect on the visibility from the wheelhouse. In the illustration the red shading shows where the breakwater arrangement was to be placed.

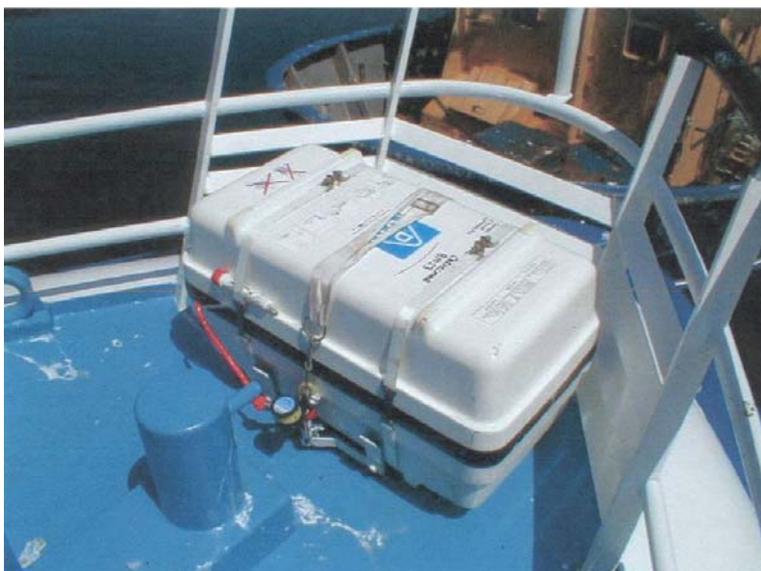
Fig. 4

The stowage arrangement is shown in the illustration, Fig. 4, below.

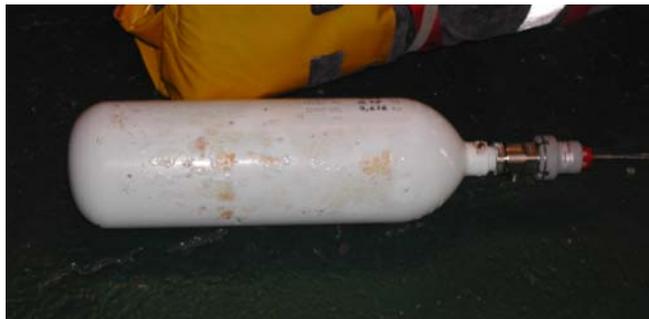
The gas cylinder was inspected and check weighed. There was no weight loss, but there were some rust stains which were removed and the cylinder repainted.

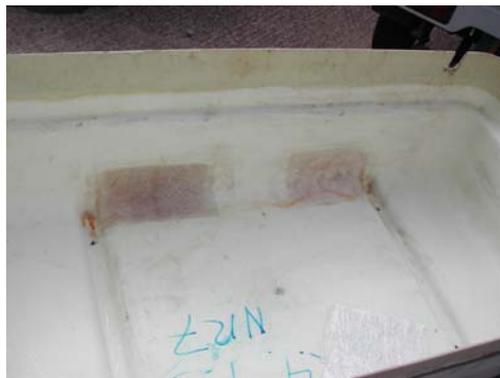
Upper container half: A small area of gel coat was damaged and repaired using a proprietary repair material. No damage was noted to the interior of the container half.

Lower container half: No damage was noted to the exterior of the container half, but two cracks were discovered on the interior which were repaired using glass fibre matting as a precautionary matter. The cracking was in the area where the gas cylinder is placed and it is believed the damage may have occurred by the cylinder knocking against the container when the vessel was sailing into a heavy head sea. The container seal was replaced as required.

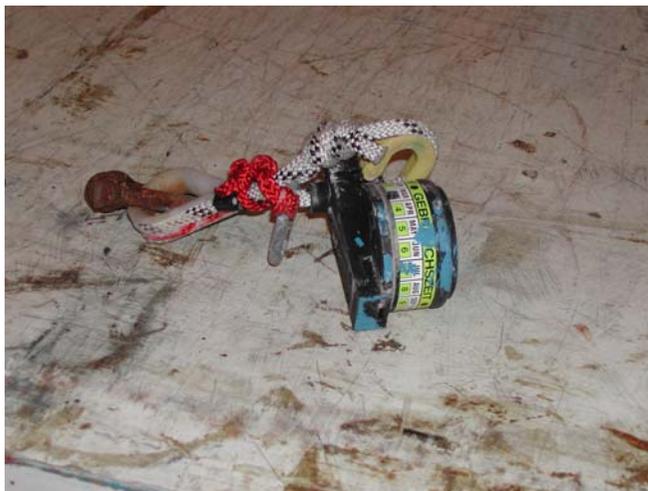
The Hammar hydrostatic release unit was tested in an air pressure chamber and operated in accordance with the designed parameters.
