LIFERAFT ON THE BOW PROJECT

PROJECT DEFINITION

Period of Trial: 2 years – commencing March 2001

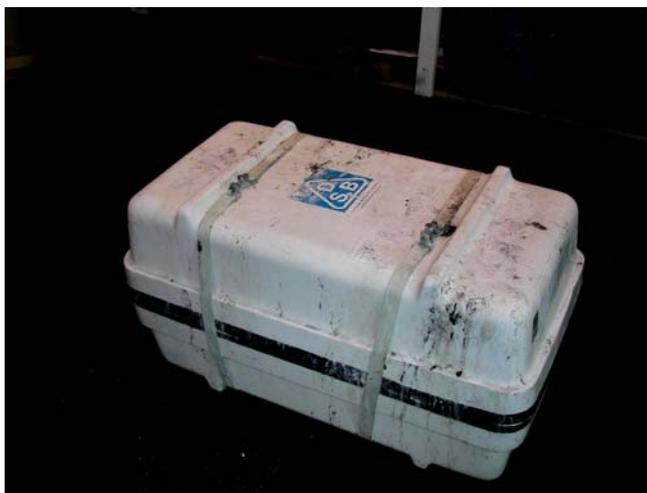
There was a delay in arranging for the service of the trial liferaft in 2003 as the Carhelmar was refitted and the service date did not correspond with the refitting period. As a consequence the liferaft was not collected for its second service until the end of June 2003.

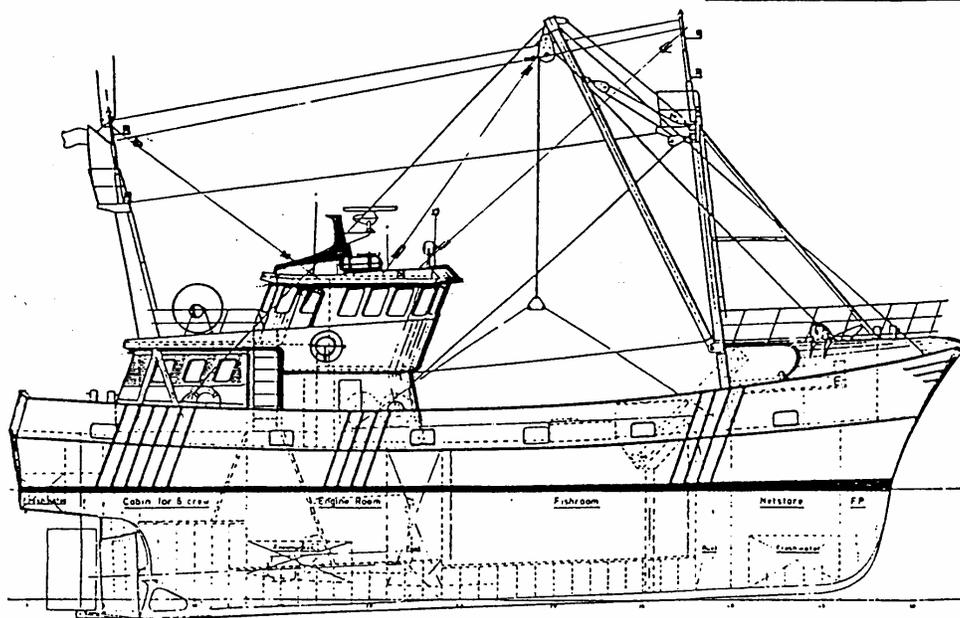
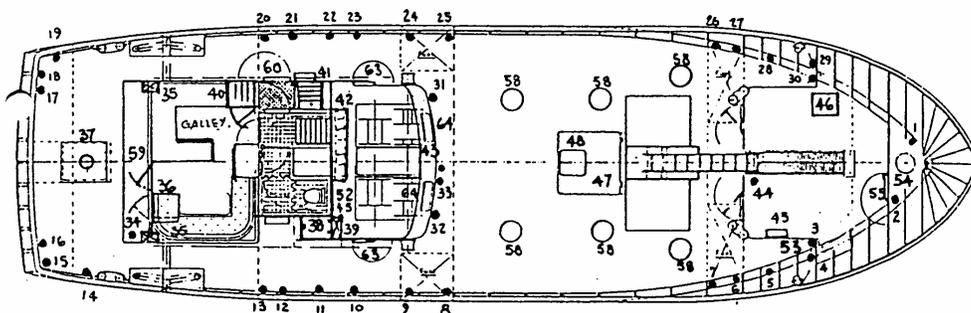
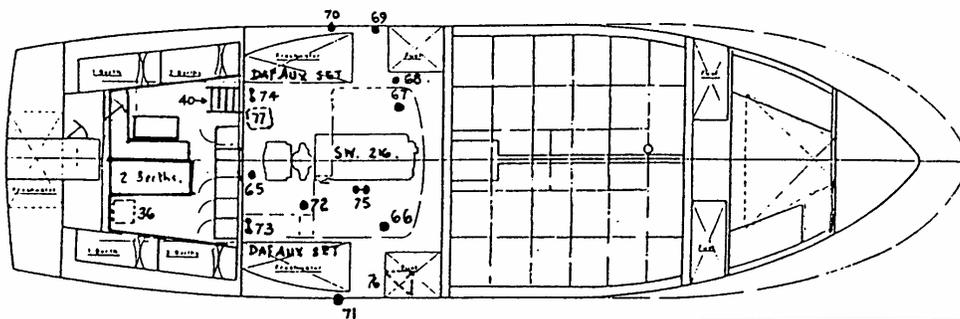
ANNEX 1

Length o.a.	78'-1"	23.80 m
Length registered	77'-10"	23.20 m
Breadth mid	27'-4"	8.80 m
Depth mid	12'-6"	3.80 m
Draught max	11'-6"	3.50 m
